Inspection report <i>THIS DOCUMENT IS NON-NEGOTIABLE</i>	Inspection Number	
	Report Date	Page 1 of 23

From	TTS	Client name:	
Contact:	Robin Huang	Contact:	
Tel/Fax:	0086-592-5219 260	Tel/Fax:	
E-mail	Inspection@tts-global.net	E-mail:	
Inspector(s)	LCC	Cc:	
Supplier		Product description	Micro beer brewery system 500L Brewery Project
Factory name:

D-CHECKING LIST

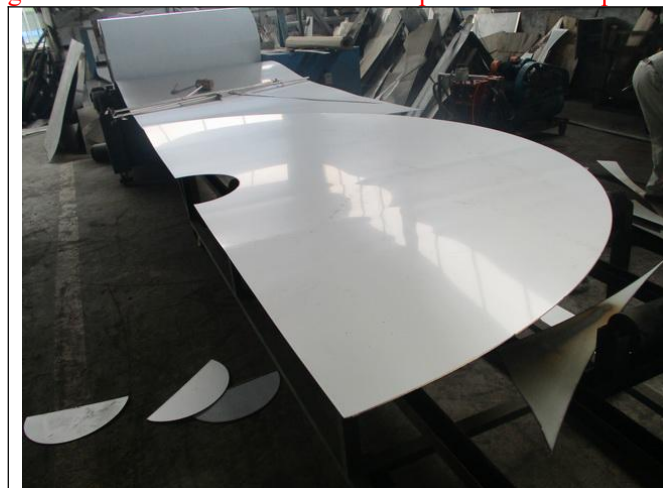
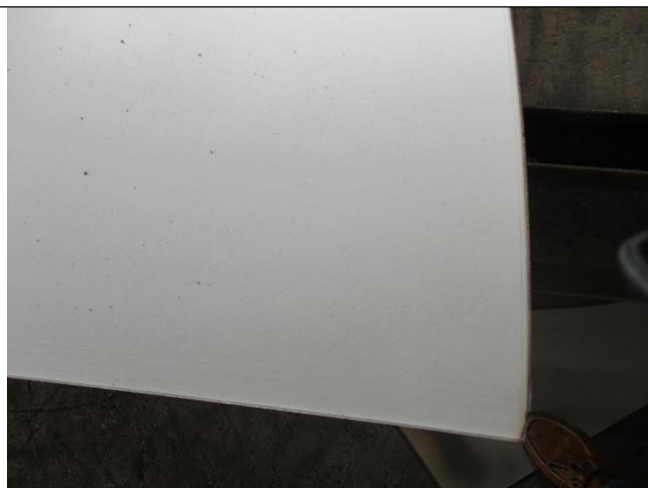
Reply: The inspector found a lot of stainless steel in the workshop, but the factory does not provide the certificate for the material, the factory claimed they can cut one part to be tested in one authoritative lab (government institute) and get the certificate for the material as per the client request.

Stainless steel

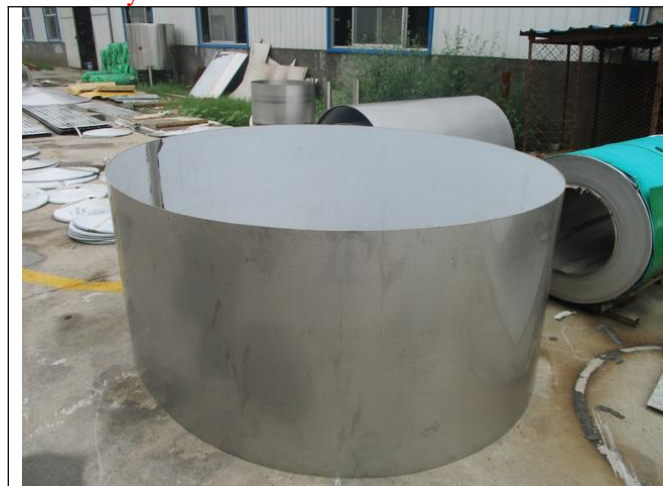
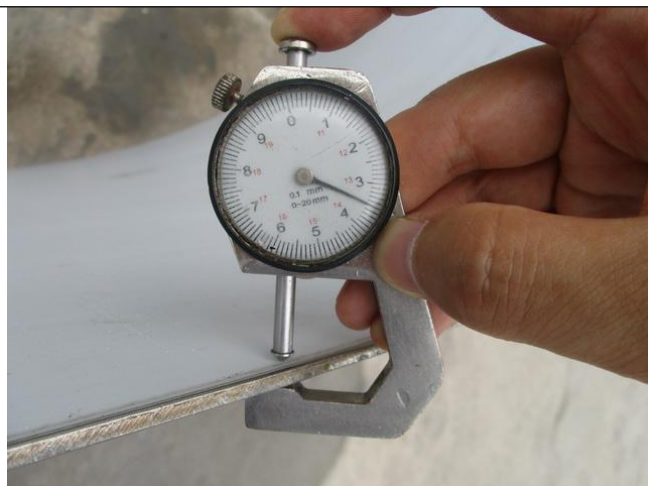
Reply: The factory claimed no 2mm or 3mm thickness of plates at warehouse in today, but inspector found the thickness was 3.5mm of the interior using plate on site. Factory claimed they can use the client request thickness plates if necessary.

Stainless steel

Size check: 3.5mm

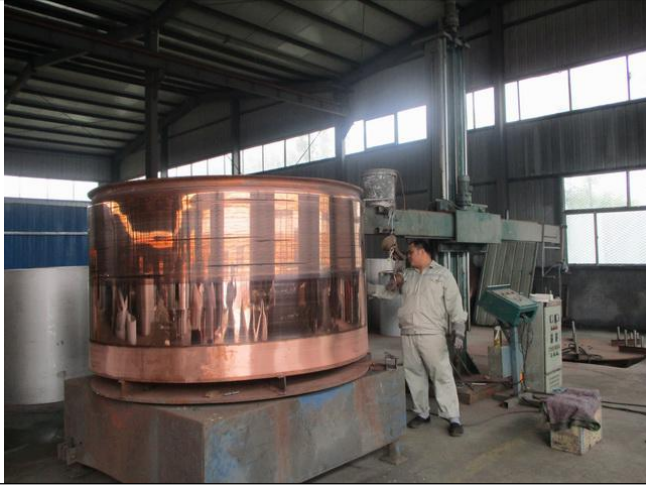
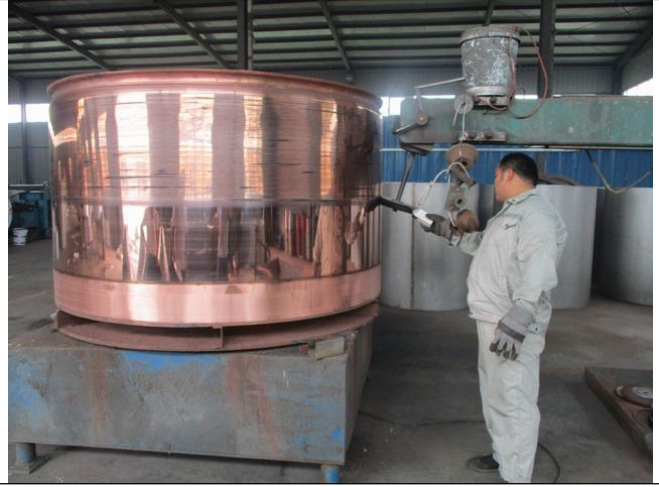
Reply: The actual finding was closed to the client request.

Polishing equipment

Polishing check

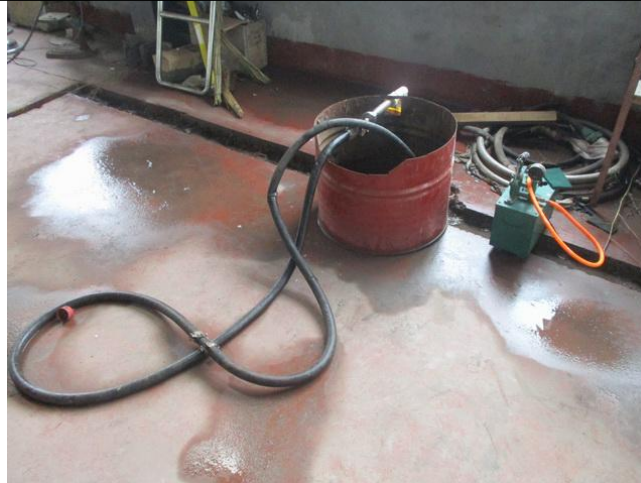
Reply: Only found a simple pressurizing test equipment in the workshop, the factory claimed they would test in strictly and accordance with the requirements of standard, when a new product was finished

Pressurizing test equipment

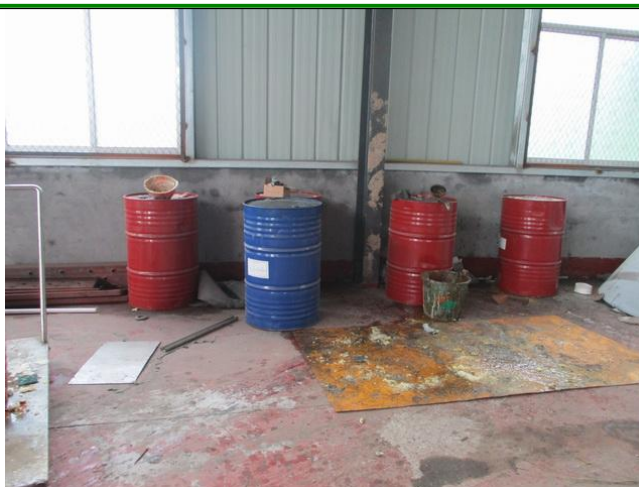
Reply: The factory claimed the polyurethane foaming machine was broken and has been sent to the manufacturers for repairing, So the inspector only see filled the insulation manually in inspection during

Filled the Insulation manually

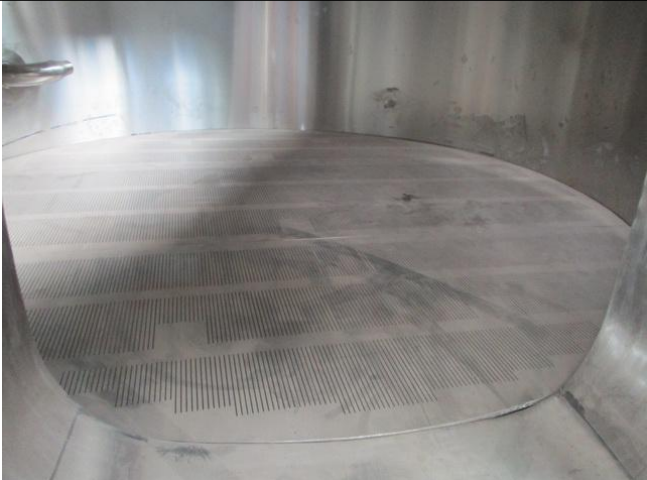
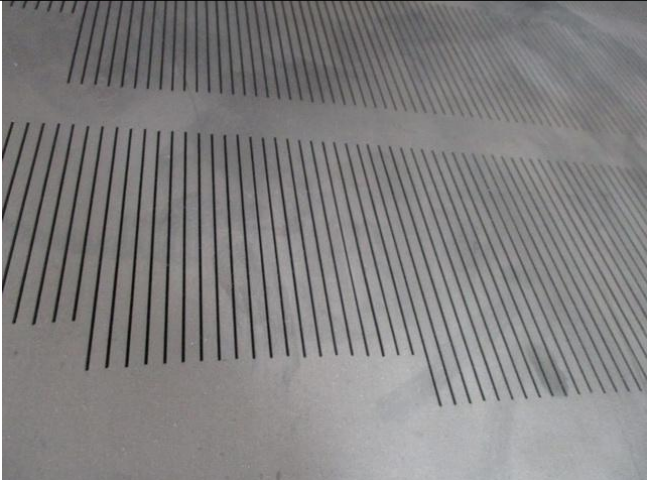
Reply: The factory claimed the filter was purchased from partner factories, and they could request the partner factory make it as per client request.

The False Bottom/Filter	The False Bottom/Filter

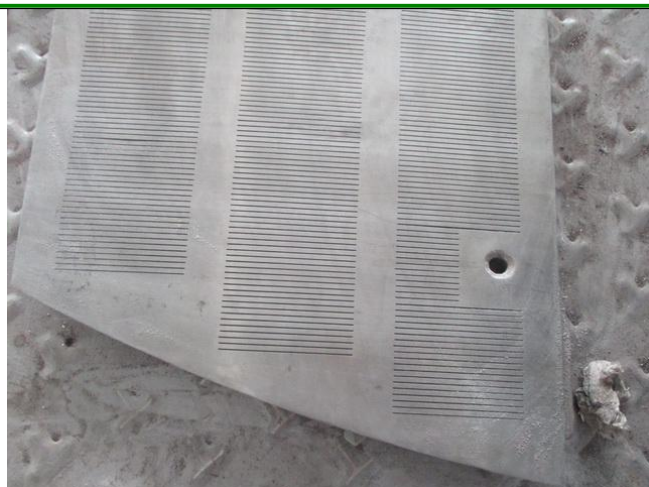
The False Bottom/Filter:front view

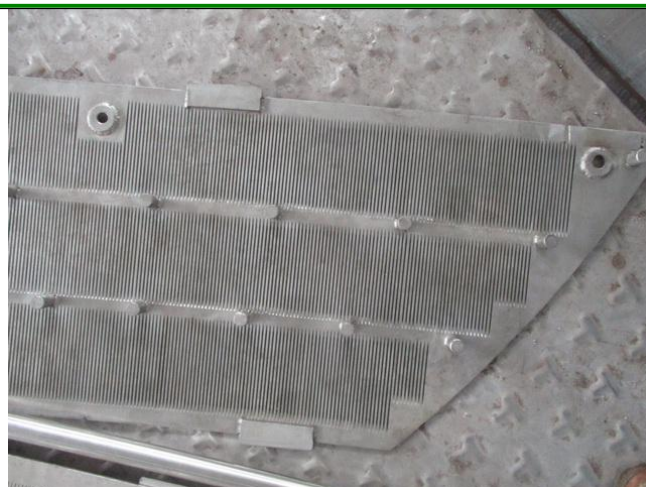
The False Bottom/Filter:back view

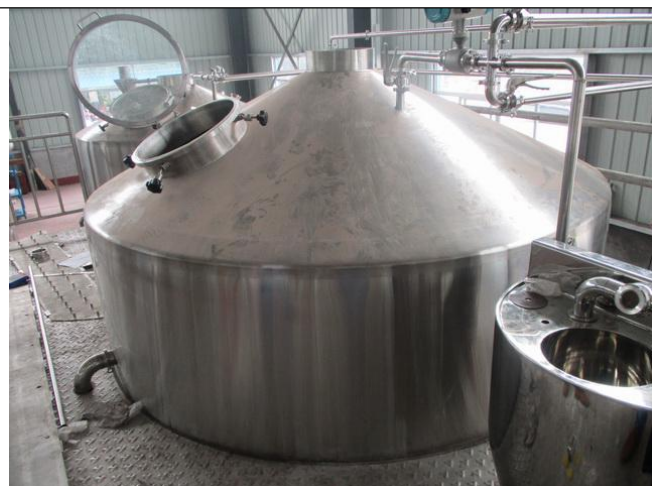
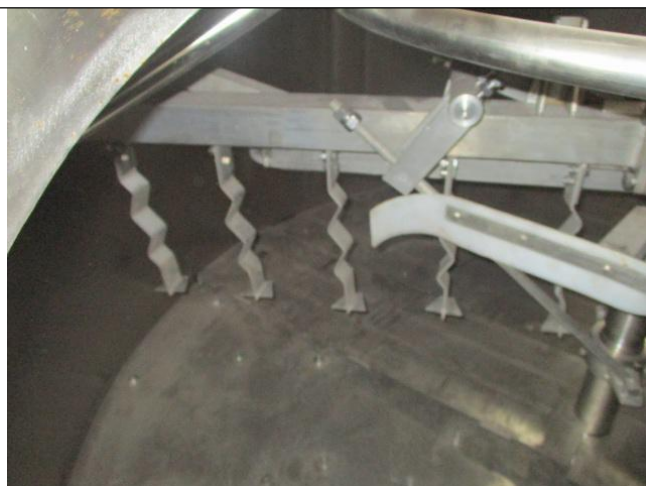
Reply: The actual finding was closed to the client request.

The rake

New-style rake

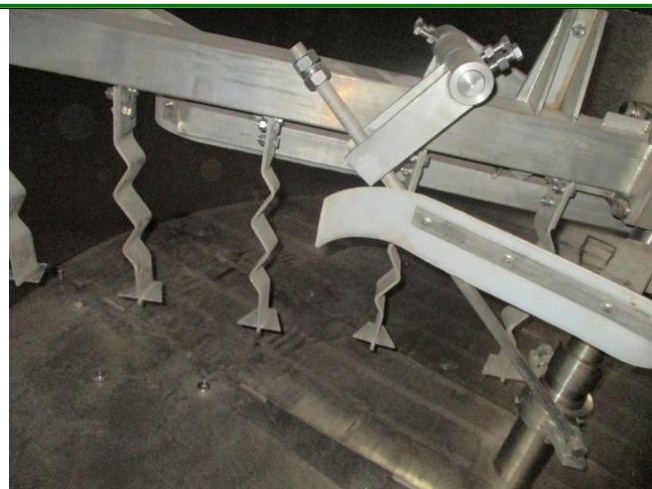
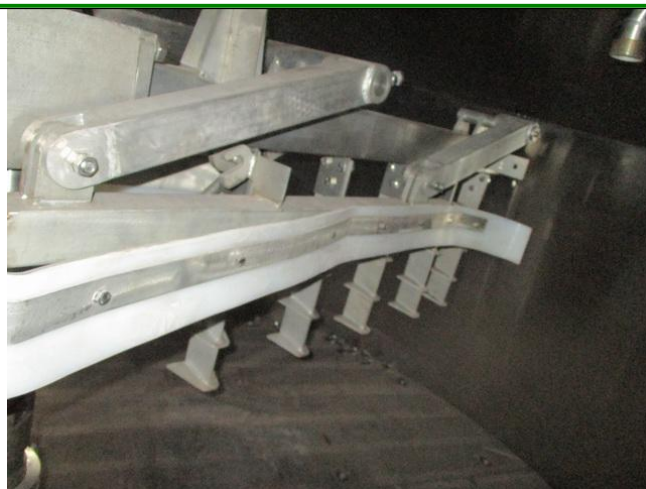
New-style rake

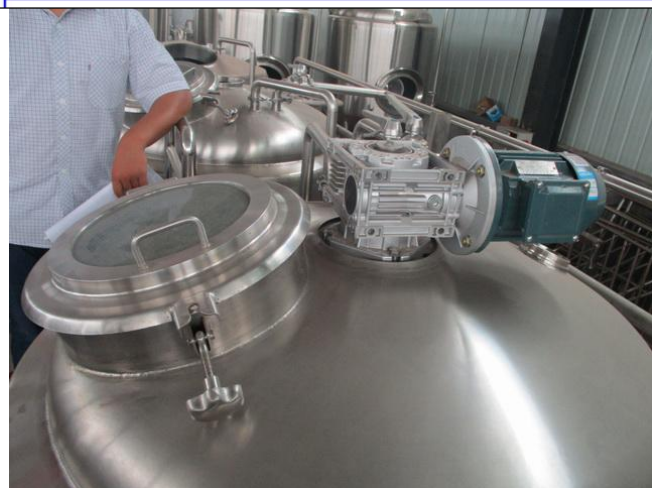
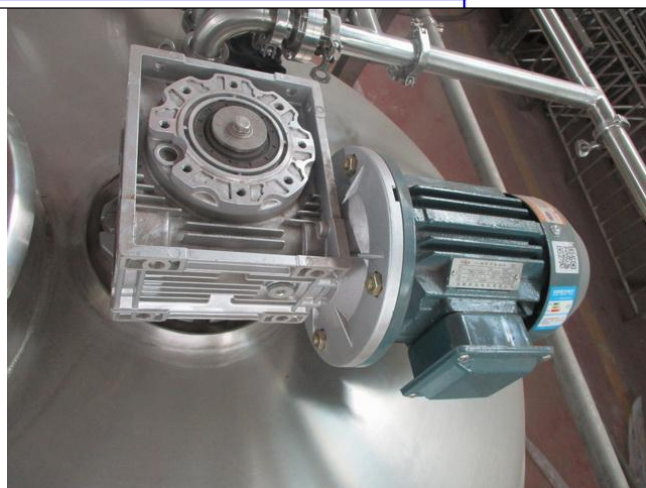
Reply: Actual found the reducer was horizontal turbine reducer, instead of vertical turbine reducer

The reducer in the rake

Horizontal reducer

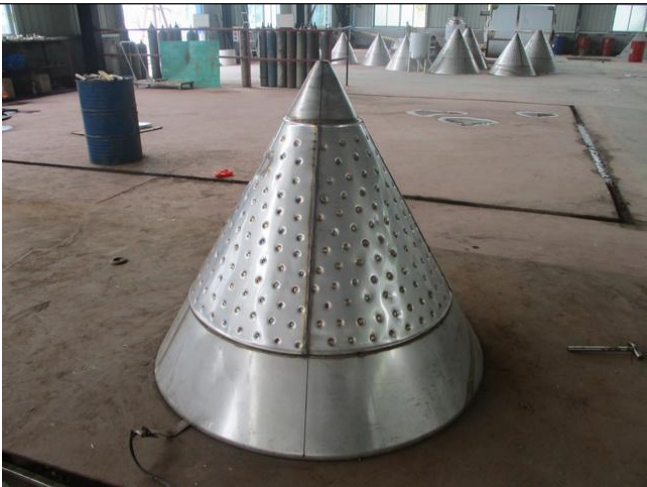
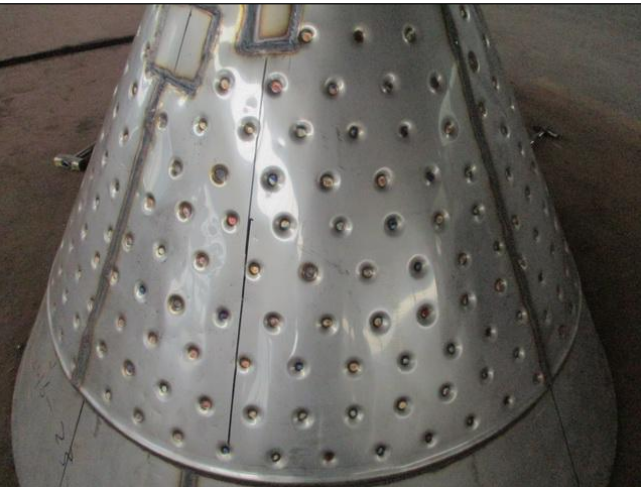
Reply: Meet to the client’s requirements.

Dimple jacket	Dimple jacket

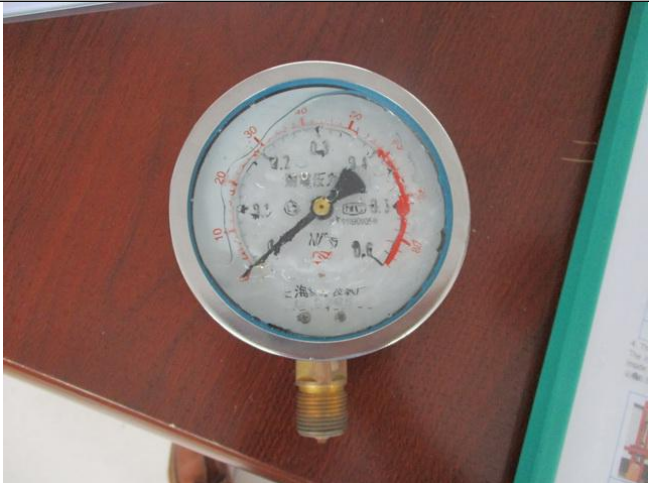
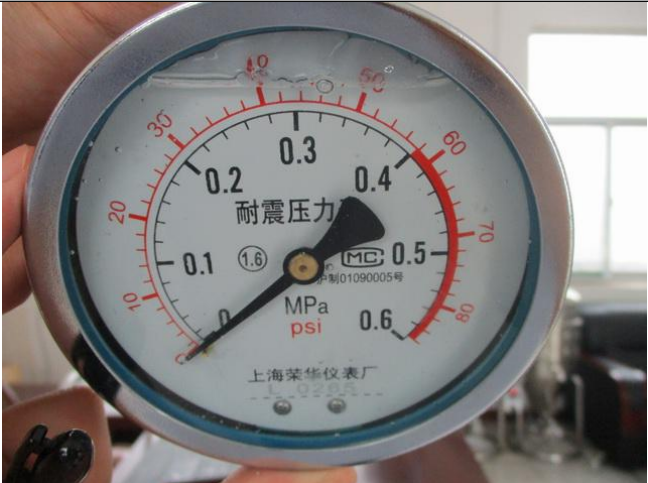
Reply: Meet to the client's requirements.

Pressure gauge	Pressure gauge

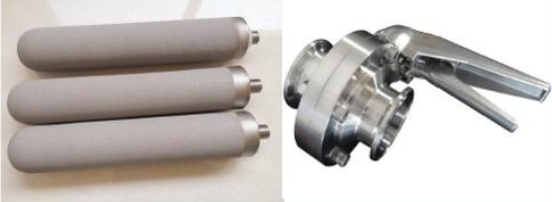
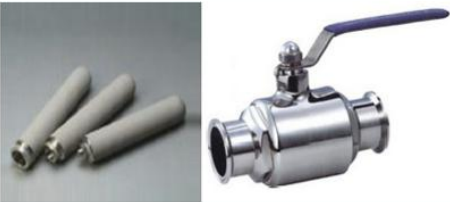
The selection of an appropriated carbonation stone with a bigger size Φ60mmx300mm, and equipped with butterfly valve. Carbonation stone(Φ60mmx300mm) butterfly valve versus a others carbonation stone(Φ60mmx200mm) ball valve.

carbonation stone(Φ60mmx300mm) butterfly valve	others carbonation stone(Φ60mmx200mm)ball valve

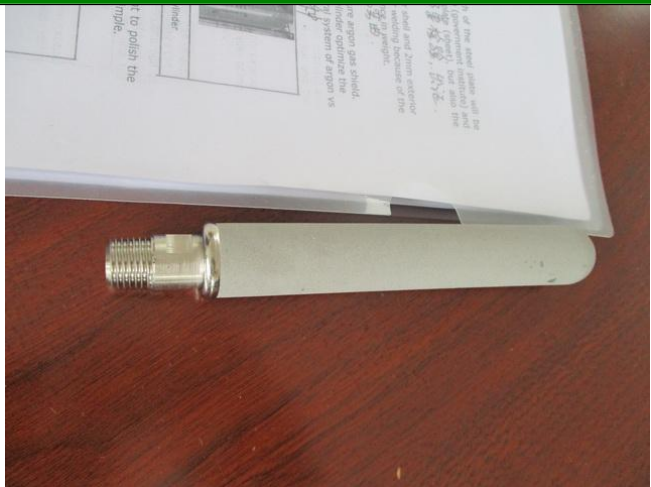
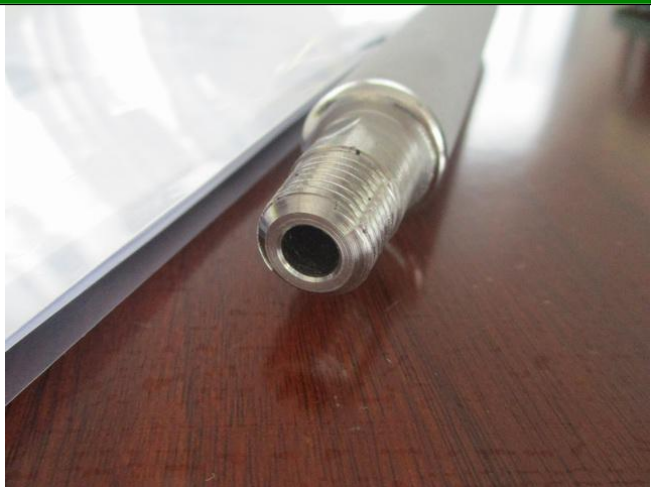
Reply: Meet to the client’s requirements.

Carbonation stone	Carbonation stone

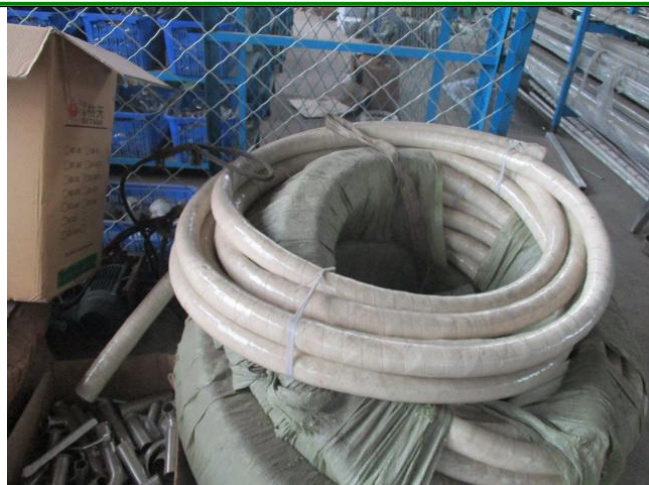
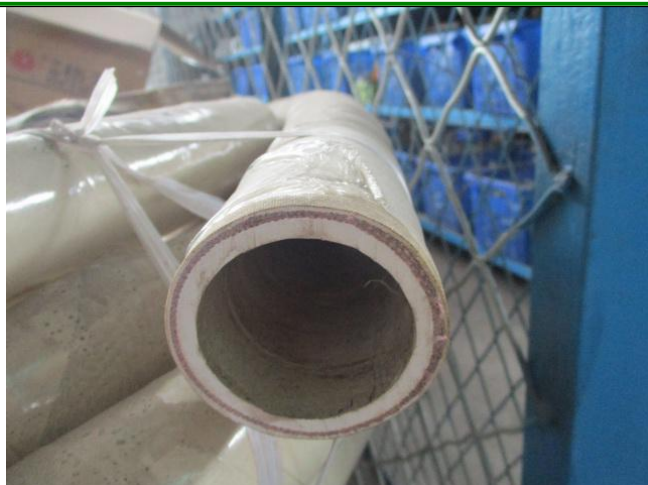
Reply: Factory also used the rubber hose on the machine, but no food-grade level certificate was available when inspection. They claimed they can let the hose manufacturer provided the certificate if necessary.

Food-grade rubber hose

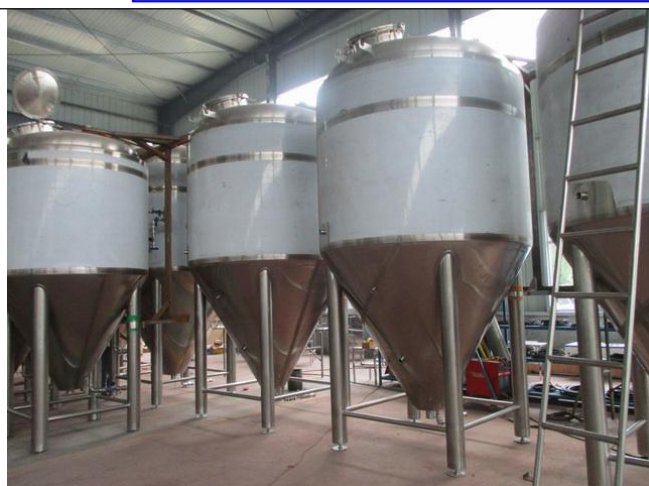
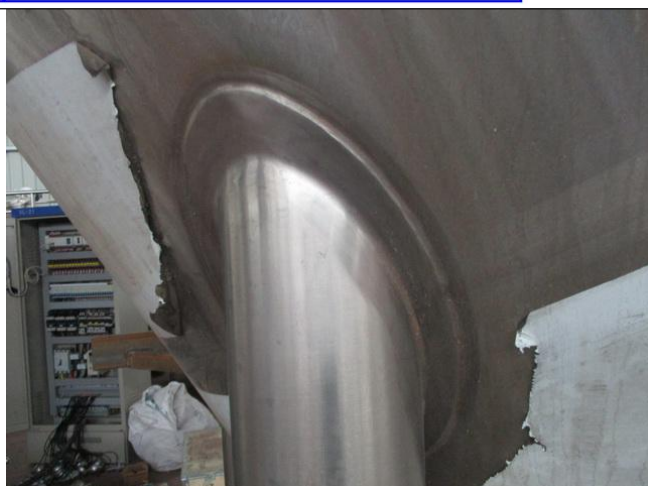
Reply: Found the machines use the stainless material, it can not confirm it is SUS304 or not. Factory claimed it is SUS 304 and they could provide the material certificate if necessary.

Legs of tanks

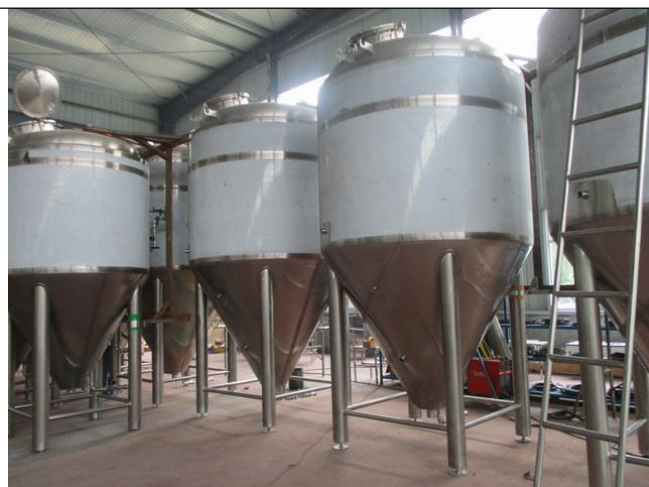
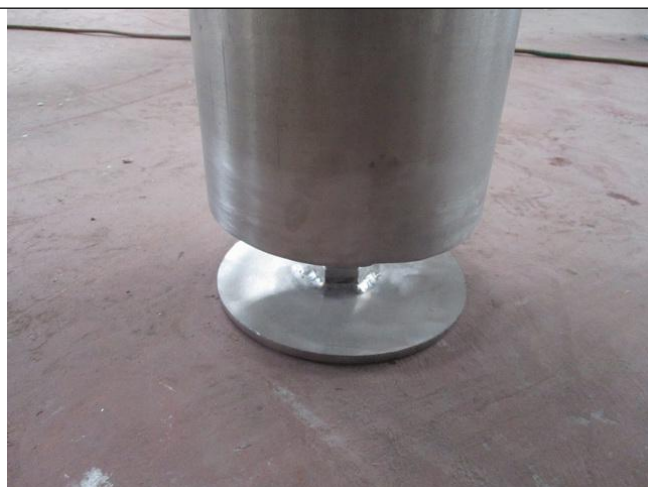
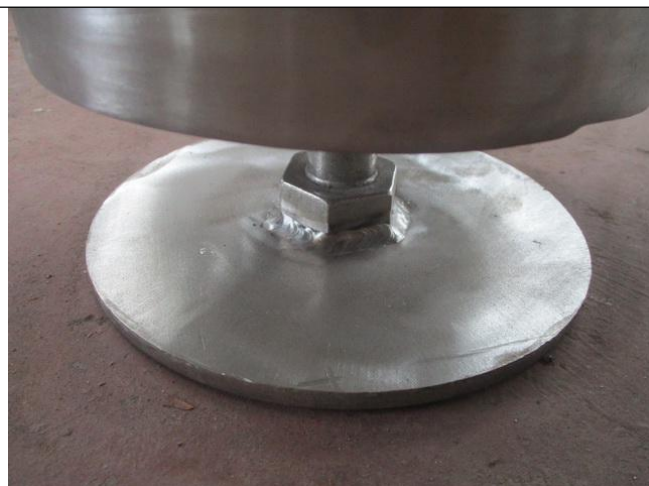
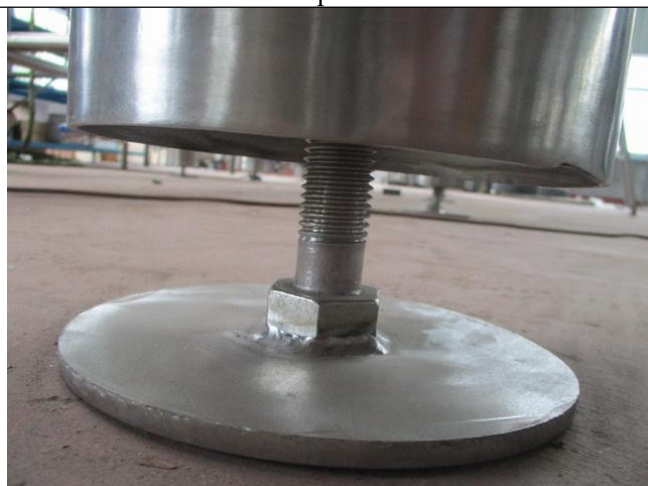
Reply: Actual found the foot pad was simple foot pad, instead of heavy duty foot pad, the factory said that they can be

Simple foot pad

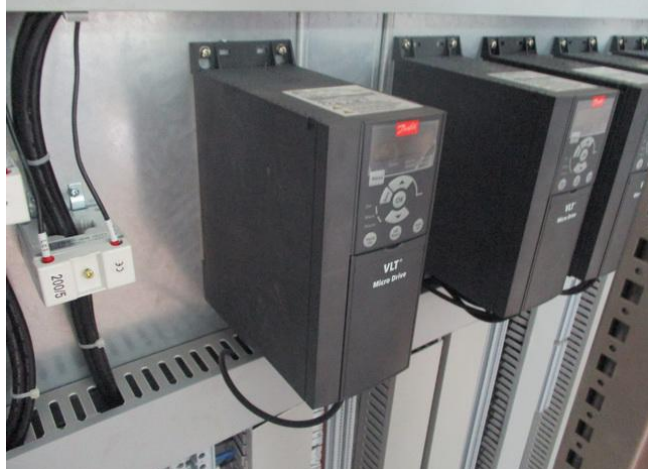
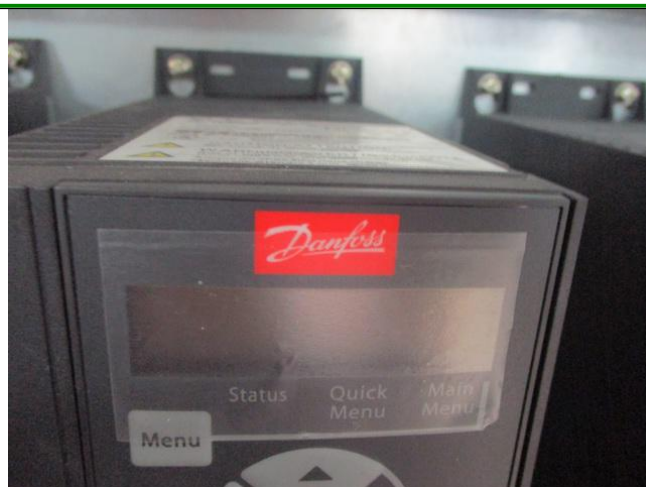
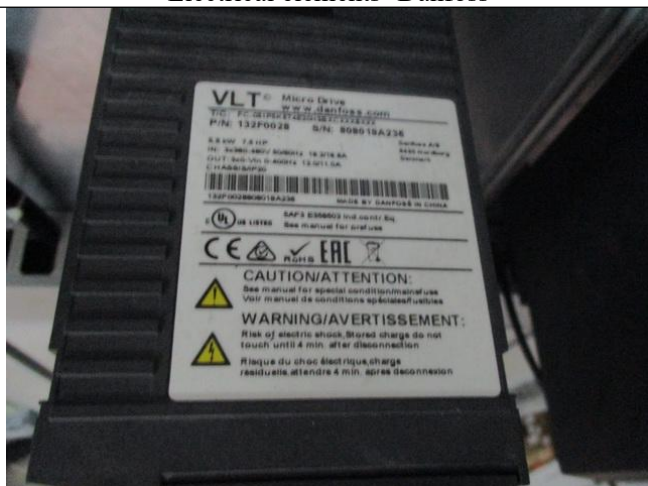
Reply: Found the world wide brand electrical elements used, such as danfoss, Schneider and Siemens.

Electrical elements- Danfoss

Electrical elements- Danfoss(CE)

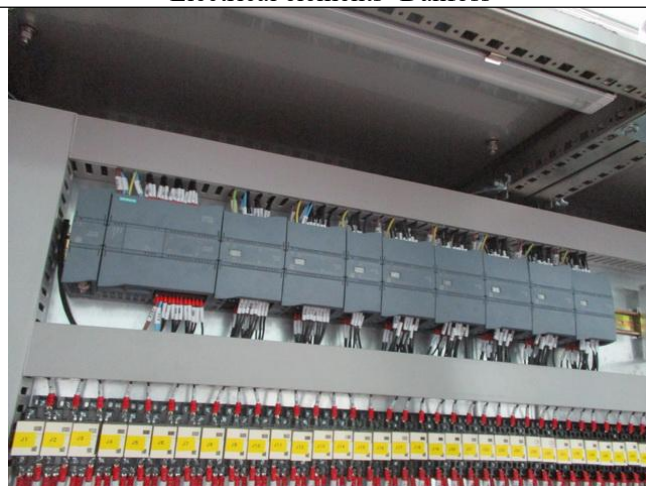
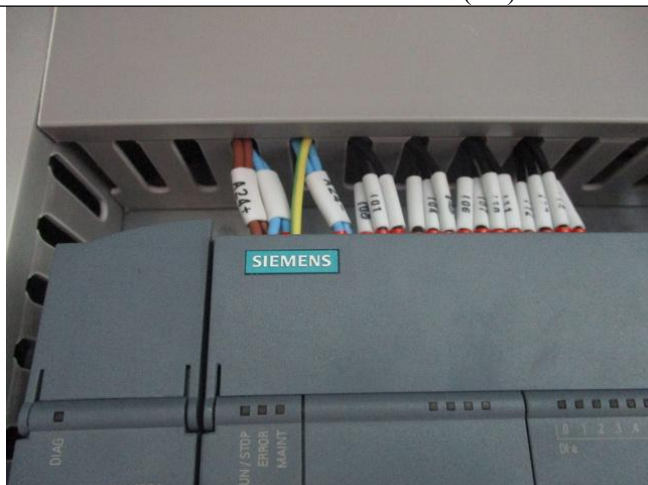
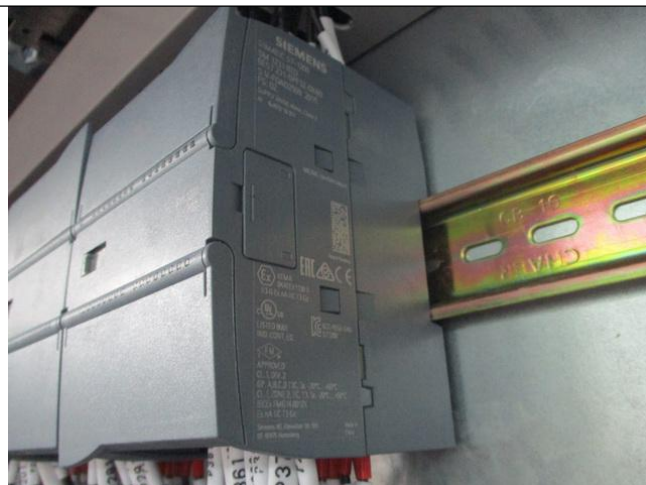
Electrical elements- Siemens

Electrical elements- Siemens(CE)

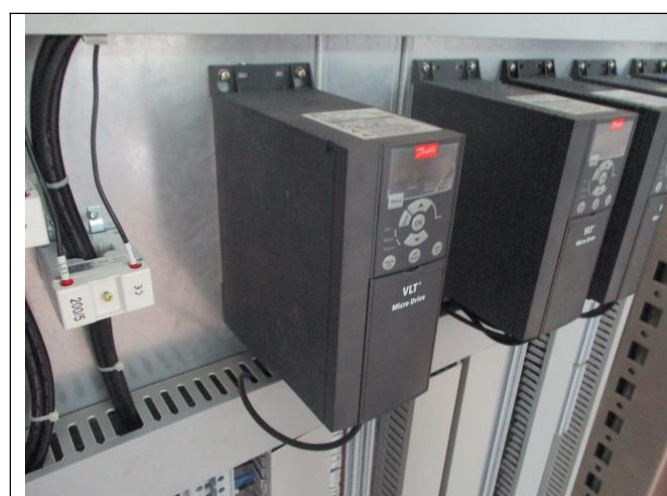
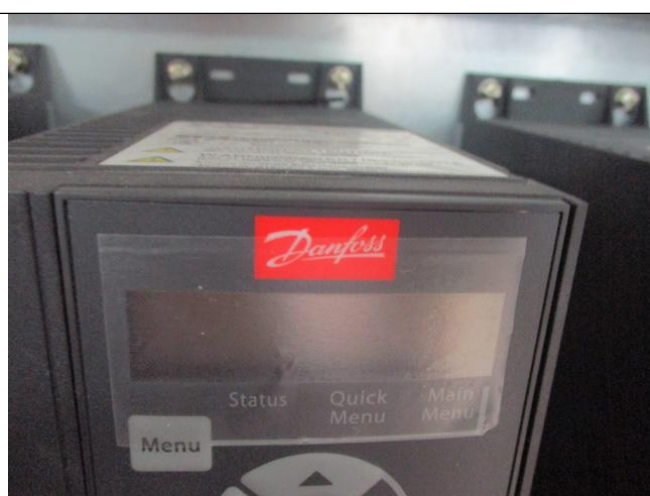
Reply: Found the VFD controlled motor brand was danfoss on the available machine, but they can buy it(other brand VFD) according to the customer's request

VFD controlled motor

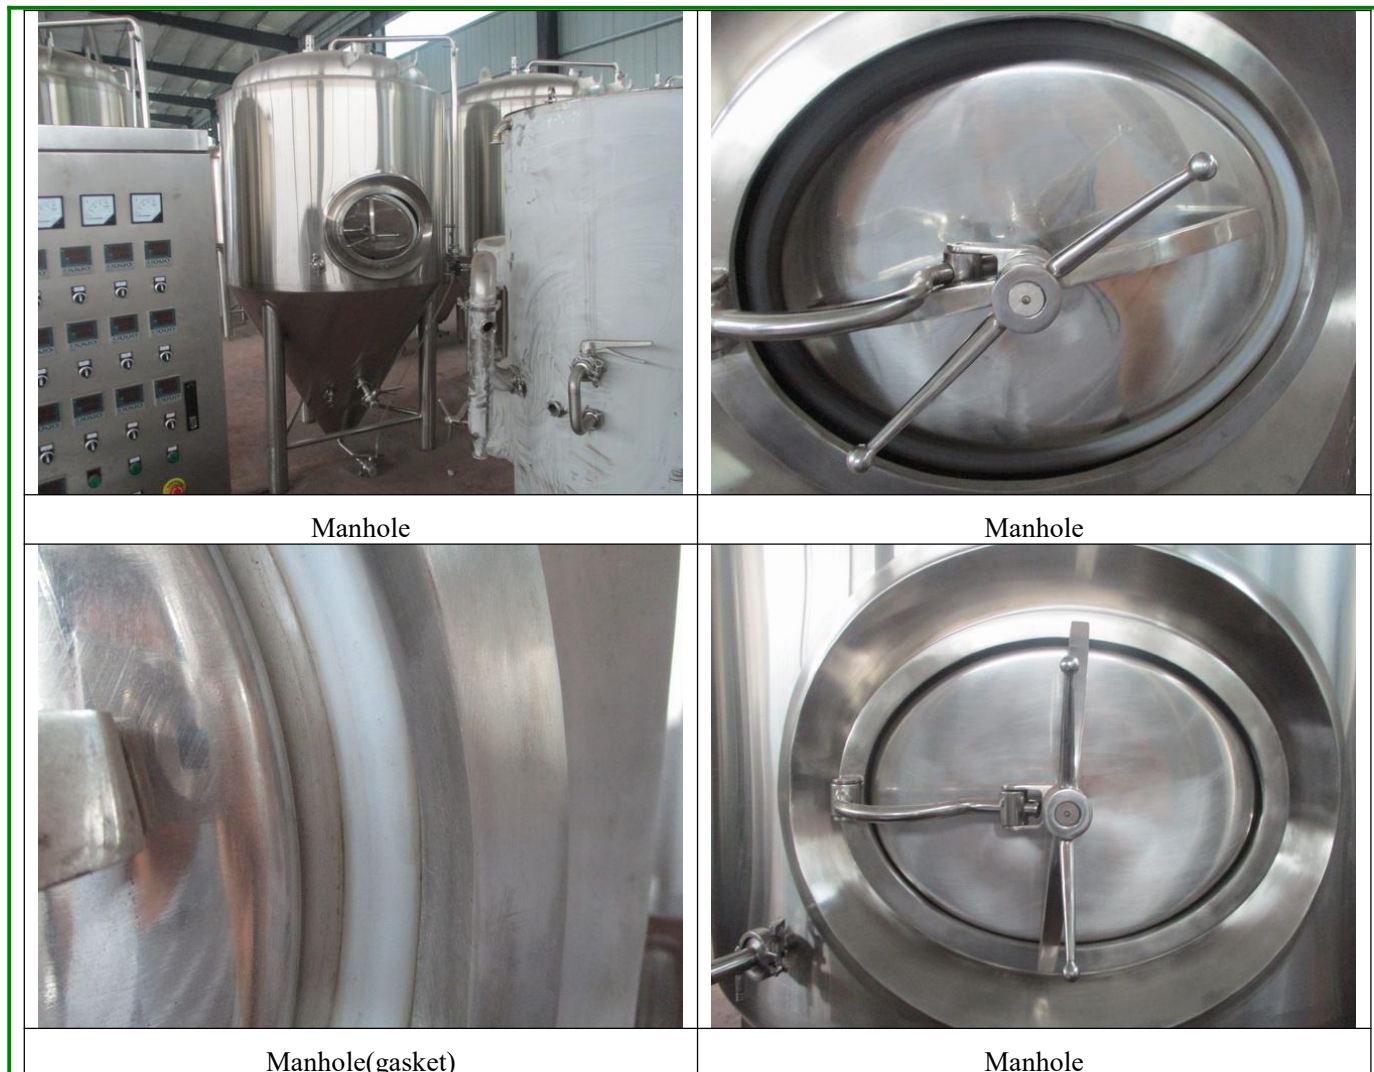
Reply: The actual finding was similar to client request.

Manhole

Manhole(gasket)

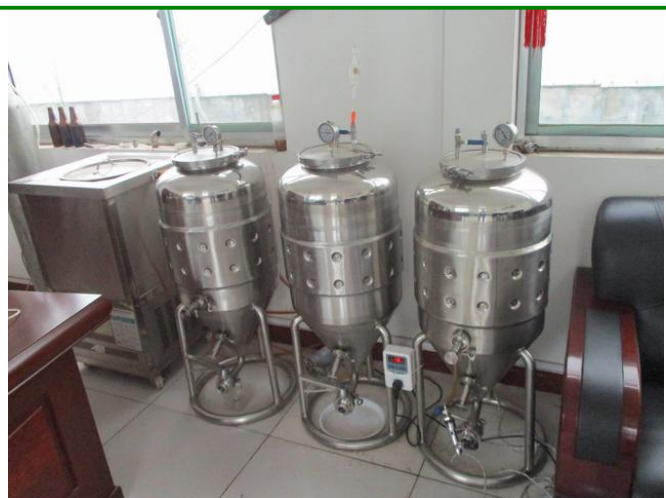
16. Mini- micro beer brewery system
